HISTORIC ATTICS: HOW TO RETROFIT WITH ENERGY & INTEGRITY IN MIND

A THESIS

BALL STATE UNIVERSITY

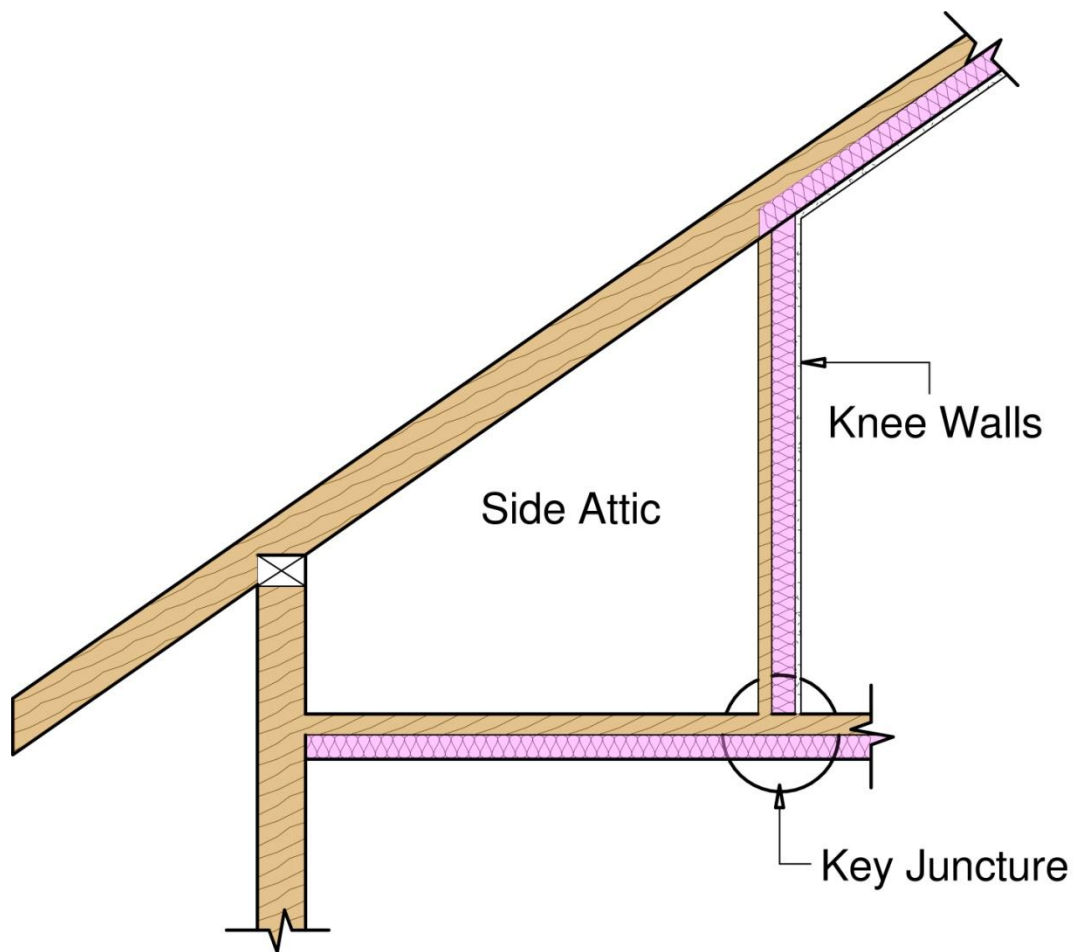
Figure 5.3 Insulation at the Key Juncture⁹

The second alternative uses the same construction as the conventional knee wall approach, however, with the addition of careful attention to insulation and air sealing. The main issue is the Key Juncture. This term is used for the space between the attic floor under the knee wall and the ceiling below; it is not taken into account and commonly overlooked.⁸ This area provides an opportunity for air leakage from the conditioned attic space, as well as the rooms below that are connected to the attic. Correct sealing of this space is crucial in order to maintain an air barrier that matches up with the thermal barrier. To ensure that a continuous

thermal and air barrier is achieved, not only will this space need to be air sealed, but additional insulation will need to be installed to the floor of the side attic as well as to the back of the knee wall. If the attic is not insulated correctly, heat and air will escape through the side attics. Figure 5.3 shows how insulating the knee walls and the key juncture will create a continuous air and thermal barrier. Figure 5.4 is a house that was improperly insulated allowing heat to escape through the side attic, melting the snow/frost on the roof.

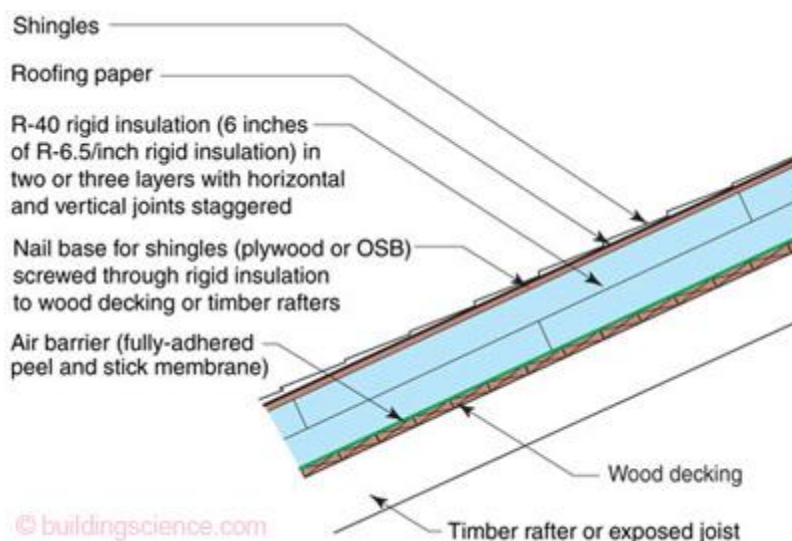
Figure 5.8 Above Roof Insulation²²

outside. The 2006 International Residential Code (IRC) Section R806.4 allows for no ventilation as long as “air-impermeable” insulation is used. Rigid foam insulation meets this standard.²¹

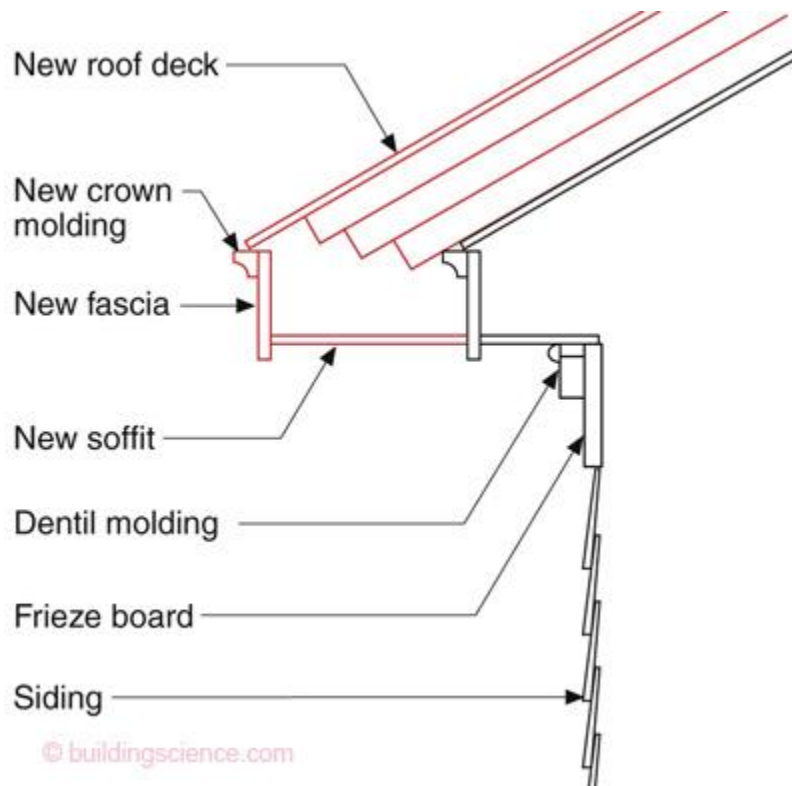
Figure 5.9 New Construction Reveals²³

In order to hide the thickness of the added above roof insulation, new trim details and framing may need to be added. Figure 5.9 illustrates how Joseph Lstiburek solved this problem by designing new reveals for the roof edge. By extending the roof deck and creating a new crown molding, fascia, and soffit, the built up roof can be discreet. This in turn allows the historic exterior to maintain its appearance. Without removing the original reveals, it also permits reversibility and a record of the changes completed. Because this alternative requires careful planning and craftsmanship, it can be significantly more expensive than the more conventional approaches.

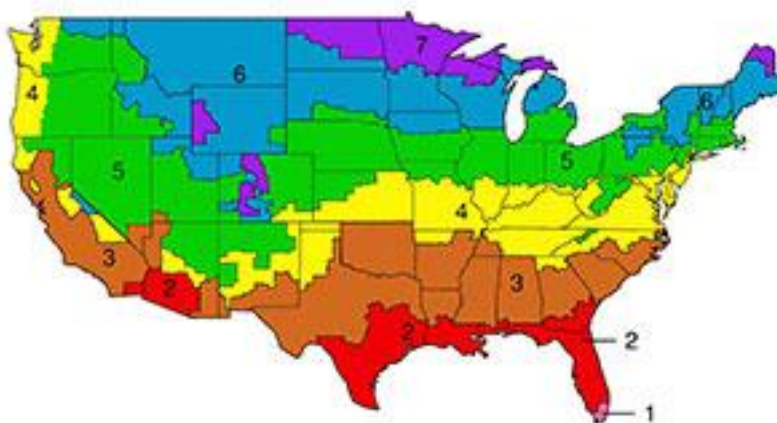
Figure 6.2 DOE Climate Zone Map⁶

Building energy code requirements are climate dependent. Figuring out which climate zone a house is in will help determine how much insulation is required for the attic. For example, Muncie, according to the DOE Climate Zone Map shown in Figure 6.2, is located in Climate Zone 5, a Cold climate area. The American Society of Heating, Refrigerating and Air-Conditioning Engineers (ASHRAE) provides a recommended R-value chart based on these climate zones to help determine the amount of insulation that should be installed for commercial buildings and residential buildings of three or more stories. According to ASHRAE Standard 90.1-2010, the building envelope requirement for Climate Zone 5 for residential attics is R-38, but if the insulation is entirely above the roof deck (discussed in Chapter 5), the requirement is R-20 of continuous insulation.⁵ Because this Standard is based off of commercial buildings and residential buildings of three or more stories, it should only be used as a guidance tool rather than use for a typical residential property of less than three stories.
